**REPORT OF INVESTIGATION INTO THE
WELLINGTON FIRE DISASTER OF
5TH NOVEMBER 2021**

**BY
PRESIDENTIAL TASK FORCE**

**For:
The Office of the President
Government of Sierra Leone**

Report Type:	Investigation Report
Date:	March 2022

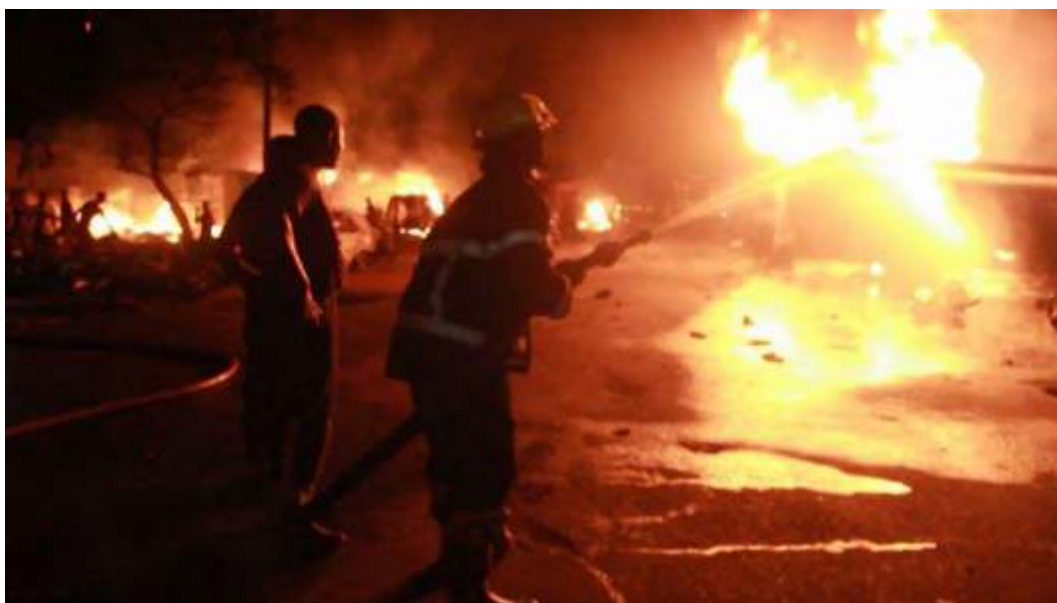
Figure 3: Cross Section of Firefighters Battling the Blaze on the night of 5th November 2021

The fire was fought by firefighters equipped with four (4) fire engines using large volumes of Class B foam solution (specific for use in petroleum-based fires) and water. The blaze was successfully extinguished at about 1:00am on the 6th of November 2021. At day break, NFF was back on the scene doing cooling off, while also helping clear the site alongside SLP, NDMA, FCC, SLRSA and MD>WU. Authority was given to the police to open up the traffic at about 15:30 hrs on the advice of the Chief Fire Officer.

NFF's response was somewhat constrained by the absence of working fire hydrants in the vicinity of the accident. Filling of fire engines had to be done at the Kissy Fire Station and Macdonald (beyond Waterloo); the closest functional hydrant to the incident scene, was at Eastern Police (which was far away). Some damage was sustained to the NFF equipment (hoses) as a result of the intensity of the blaze.

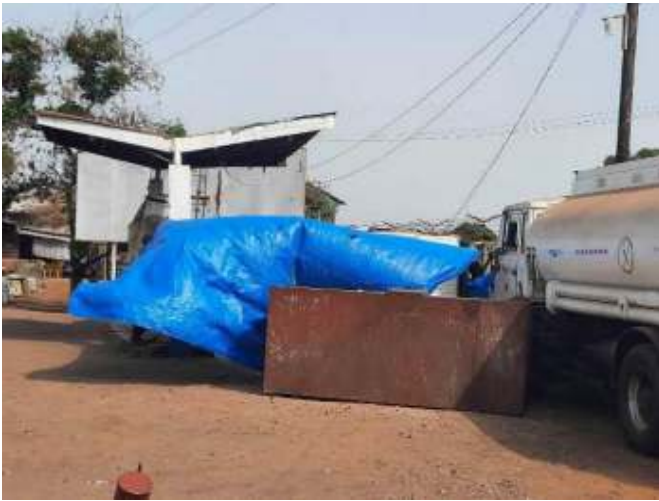
Two filling stations were located within a radius of about 100m away from where the fire broke out, and according to the station managers, the stations had an estimated combined total of six thousand litres of fuel.

Figure 10: One of two Fuel Stations near accident Scene **Figure 11: Team with one of the Fuel Station Managers**

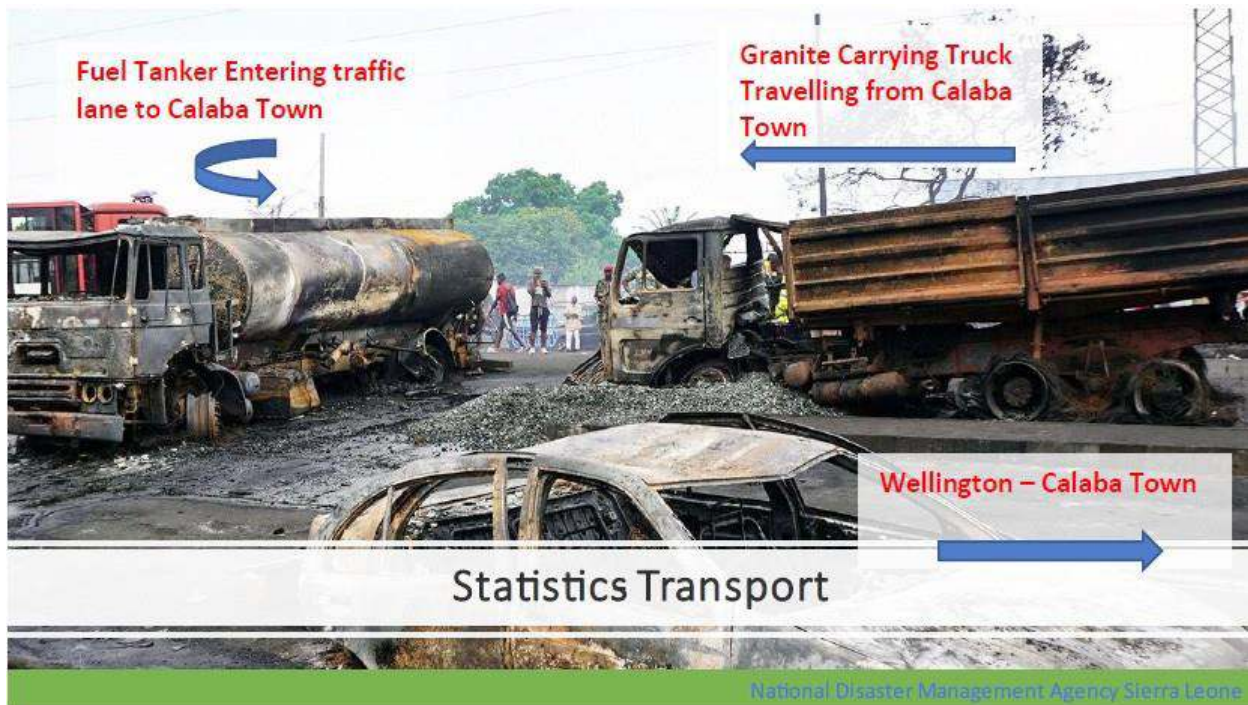
Figure 12: Accident Scene

The fire disaster was a sequel to the collision between a fuel tanker (AQB 602) loaded with 15,000 litres of petrol, which was negotiating its way into traffic in the direction of Calaba Town, and a tipper truck (AQM 928) loaded with granite stones that was travelling from Calaba Town towards Freetown along the main Bai Bureh Road (see figure 12). One school of thought is that the tipper truck may have lost control. Another explanation obtained from eyewitness accounts is that the truck had earlier violated a traffic regulation at Calaba Town and was driving at a high speed to escape the incident, resulting in the collision.

The source of ignition was as a result of an individual's attempt to disconnect the battery from the tipper truck. The fire was exacerbated due to the fact that the fuel had been leaking from the tanker for about 42 minutes, and had spread over a wide area spanning the accident site, having leaked on to the road and into nearby gutters. The spillage of fuel in the surrounding environment due to bad handling by members of the public siphoning and hoarding the fuel in different locations, is a precipitating factor responsible for the wide spread of the fire resulting in the destruction of life and properties.

The behaviour of the general public following the collision was a major contributing factor to the scale of the incident, and is a serious cause for concern. At the outset of the accident, despite the tanker driver using a megaphone borrowed from a nearby seller, to advice the public to avoid the scene, he was reportedly insulted and his advice completely ignored by the individuals eager to access the fuel. This lawlessness on the part of the public is a major factor in the spread of the fire and extent of carnage and destruction.

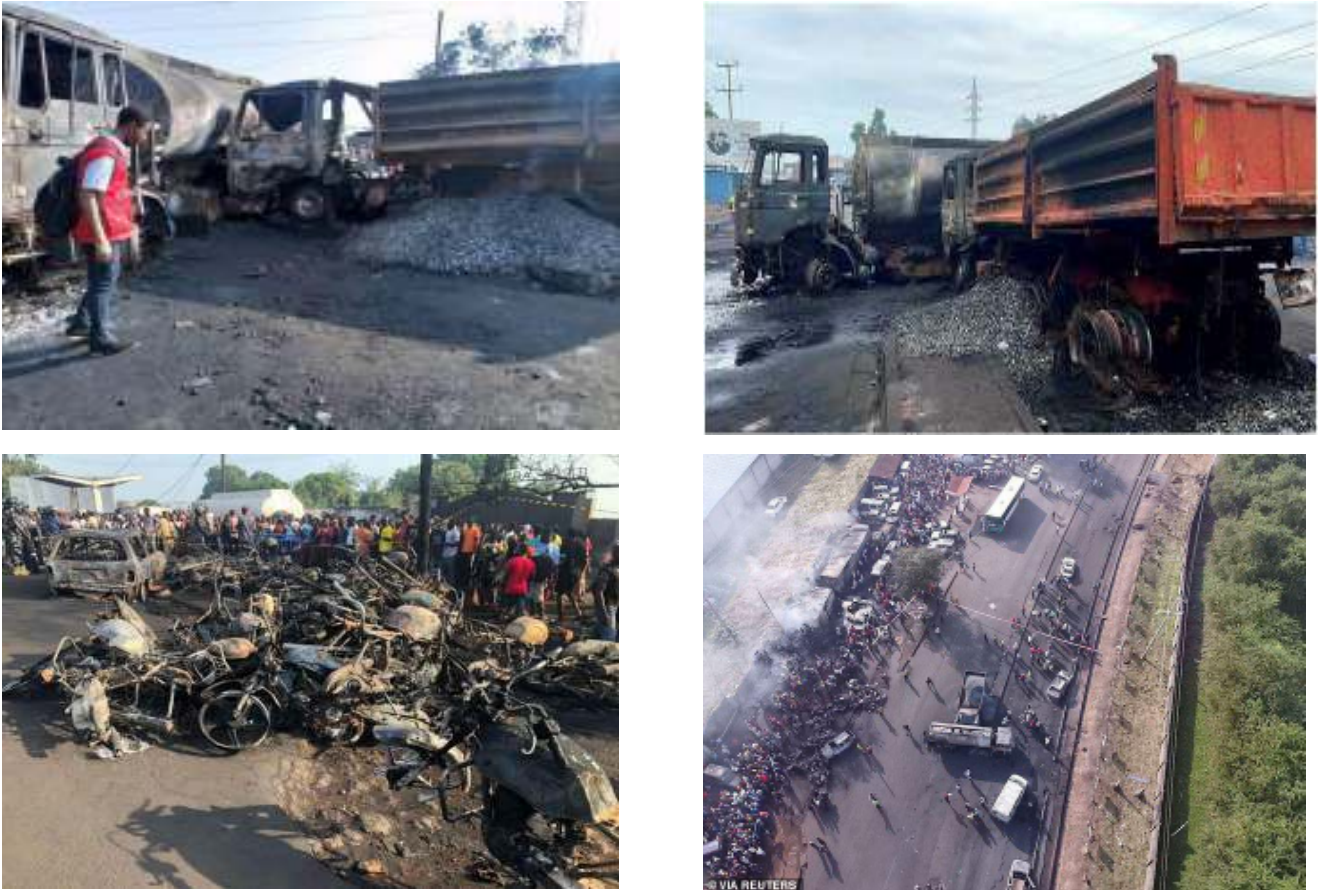
- Two (2) dwelling houses
- Five (5) small shops
- Twenty (20) vehicles
- Forty-eight (48) motorbikes, and
- Three (3) motorized tricycles (kekes)

Figure 13: Images depicting the wake of destruction left by the fire disaster

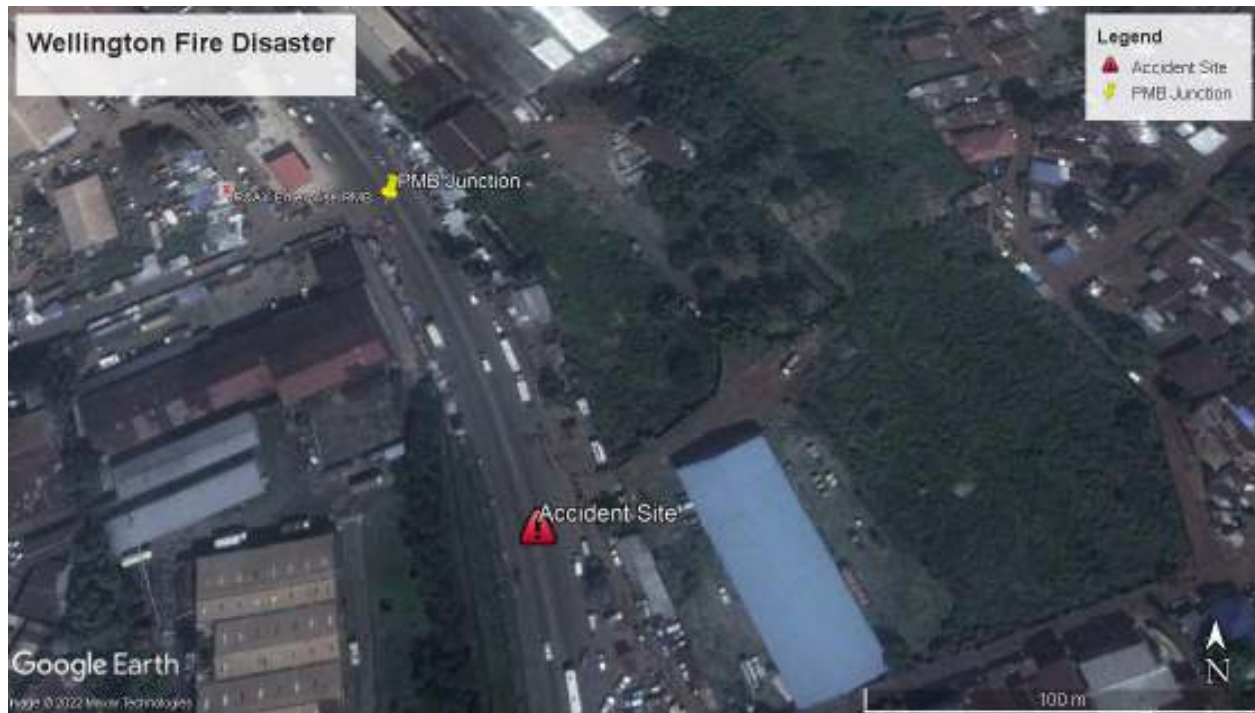
It was noted, however, that SLP personnel were stationed at the PMB junction roughly 100m from the accident scene (see figure 14).

Figure 14: Map showing Accident Site proximity to deployment of SLP Personnel

The proximity between PMB junction and the accident site is close enough for the SLP to have diverted vehicular and human traffic away from the accident. However, there is no indication that any action was taken before the explosion occurred.
