**REPORT OF INVESTIGATION INTO THE
WELLINGTON FIRE DISASTER OF
5TH NOVEMBER 2021**

**BY
PRESIDENTIAL TASK FORCE**

**For:
The Office of the President
Government of Sierra Leone**

Report Type:	Investigation Report
Date:	March 2022

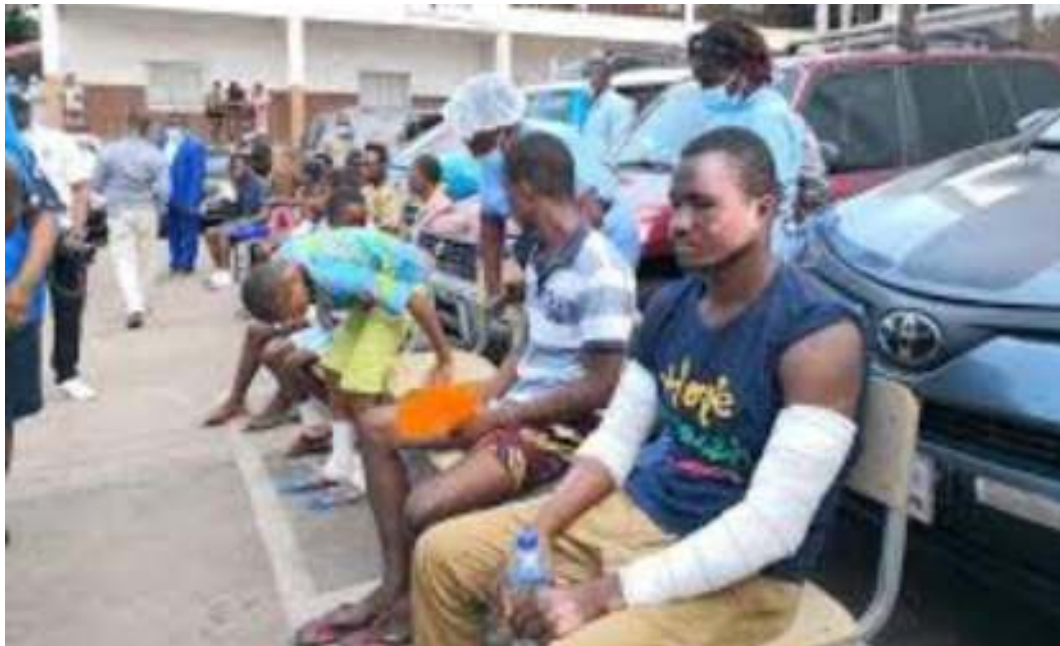
The Central Referral Hospital (Connaught) was overwhelmed with corpses and burn victims. Thus, some patients were taken to other medical facilities including 34 Military Hospital at Wilberforce, Choithrams Hospital at Hill Station, Emergency Hospital in Goderich and Rokupa Satellite Hospital.

Figure 4: Disaster Victims awaiting treatment at Connaught Hospital

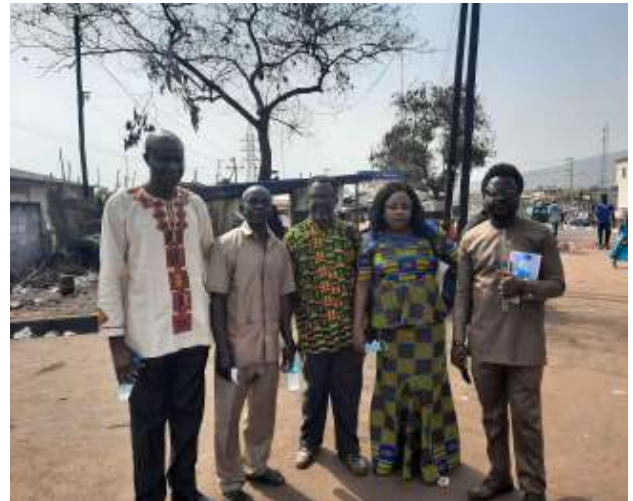
Two filling stations were located within a radius of about 100m away from where the fire broke out, and according to the station managers, the stations had an estimated combined total of six thousand litres of fuel.

Figure 10: One of two Fuel Stations near accident Scene **Figure 11: Team with one of the Fuel Station Managers**

One station manager reported that having noticed the actions of members of the public to gain access to the fuel was a recipe for disaster, he closed his station and prevented public access to the facility. He concluded that barely fifteen minutes following the closure of the station, he heard a loud explosion, followed by a raging fire. It is safe to assume that the awareness of the fuel station managers and attendants of the hazards posed by the accident, and their decision to close the stations, in addition to other preventative actions taken by them, limited the extent of the disaster. The fire spreading to either of these stations would have resulted in an undeniably more catastrophic situation of unimaginable proportions or consequences.
